uff Conservation

Gullies

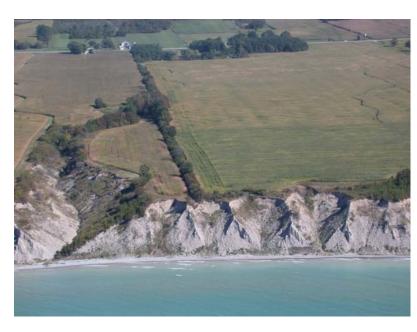
Ravines, or gullies, cutting into the clay soils of Huron County's coastline. Surface runoff accelerates through these gullies, eroding the soils. Gully slopes are prone to slumping, just as bluffs are.

Once created, they provide avenues for easy downslope movement of water from storms. The flowing water erodes soil from the sides and floor of each gully, making it wider and deeper.

Landslides, slumps, and related processes on the gully sides also contribute to the removal of slope materials. The top, or head, of the gully advances upslope, enlarging the gully system.
